TRACK 2  
PRELIMINARY SCOPING PACKAGE  
COVER SHEET

Site Description: CONTAMINATED SOIL FROM LEAK IN LINE FROM CPP WM-181 TO PEW

Site ID: CPP-16

Operable Unit: 3-07

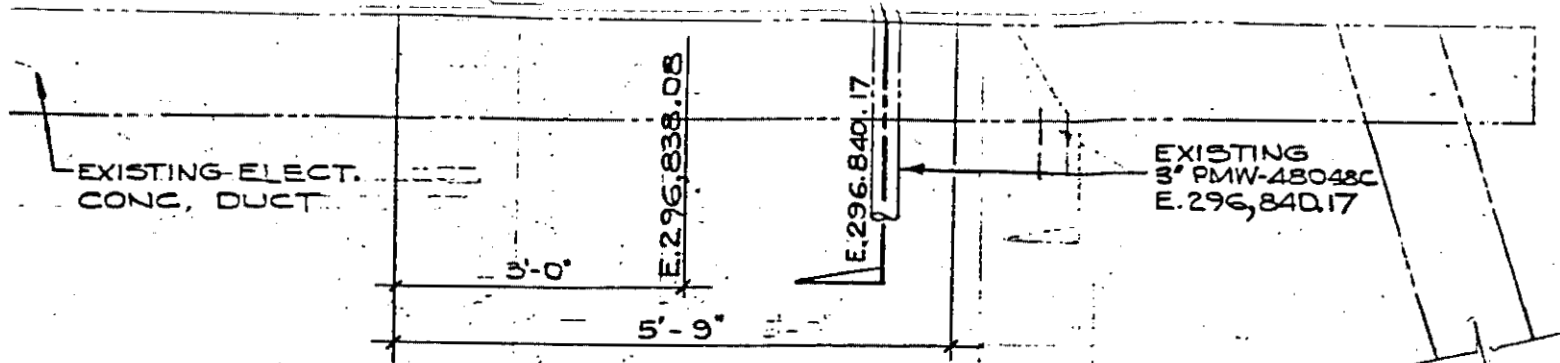
# PLAN - DIVERSION VALVE BOX C-8

3/4" = 1'-0" (DVB-WM-PW-C8)

Based upon the replacement of valve box C-8, the top of any residual contamination would be at a minimum depth of 9 feet 3 inches below land surface (bls). This depth of contamination is well documented in ICPP engineering drawings related to the replacement of valve box C-8. Given this depth to contamination, this pathway is not complete and the pathway specific historical information will not be included.	Soil: Intrusion Area: 450 ft <sup>2</sup> Volume: 1604 ft <sup>3</sup> (1)	Intrusion → Ingestion	Soil: Intrusion → Ingestion 1. Pathway is incomplete 2. There is no source between 0-6 inches and 0-10 feet for occupational and residential scenarios, respectively (Note: top of contamination is 9 feet 3 inches bls).
Based upon the replacement of valve box C-8, the top of any residual contamination would be at a minimum depth of 9 feet 3 inches below land surface (bls). This depth of contamination is well documented in ICPP engineering drawings related to the replacement of valve box C-8. Given this depth to contamination, this pathway is not complete and the pathway specific historical information will not be included.	Soil: Radiation Area: 450 ft <sup>2</sup> Volume: 1604 ft <sup>3</sup> (1)	Radiation → Ext. Exp.	Soil: Radiation → External Exposure 1. Pathway is incomplete 2. There is no source between 0-6 inches and 0-10 feet for occupational and residential scenarios, respectively (Note: top of contamination is 9 feet 3 inches bls).

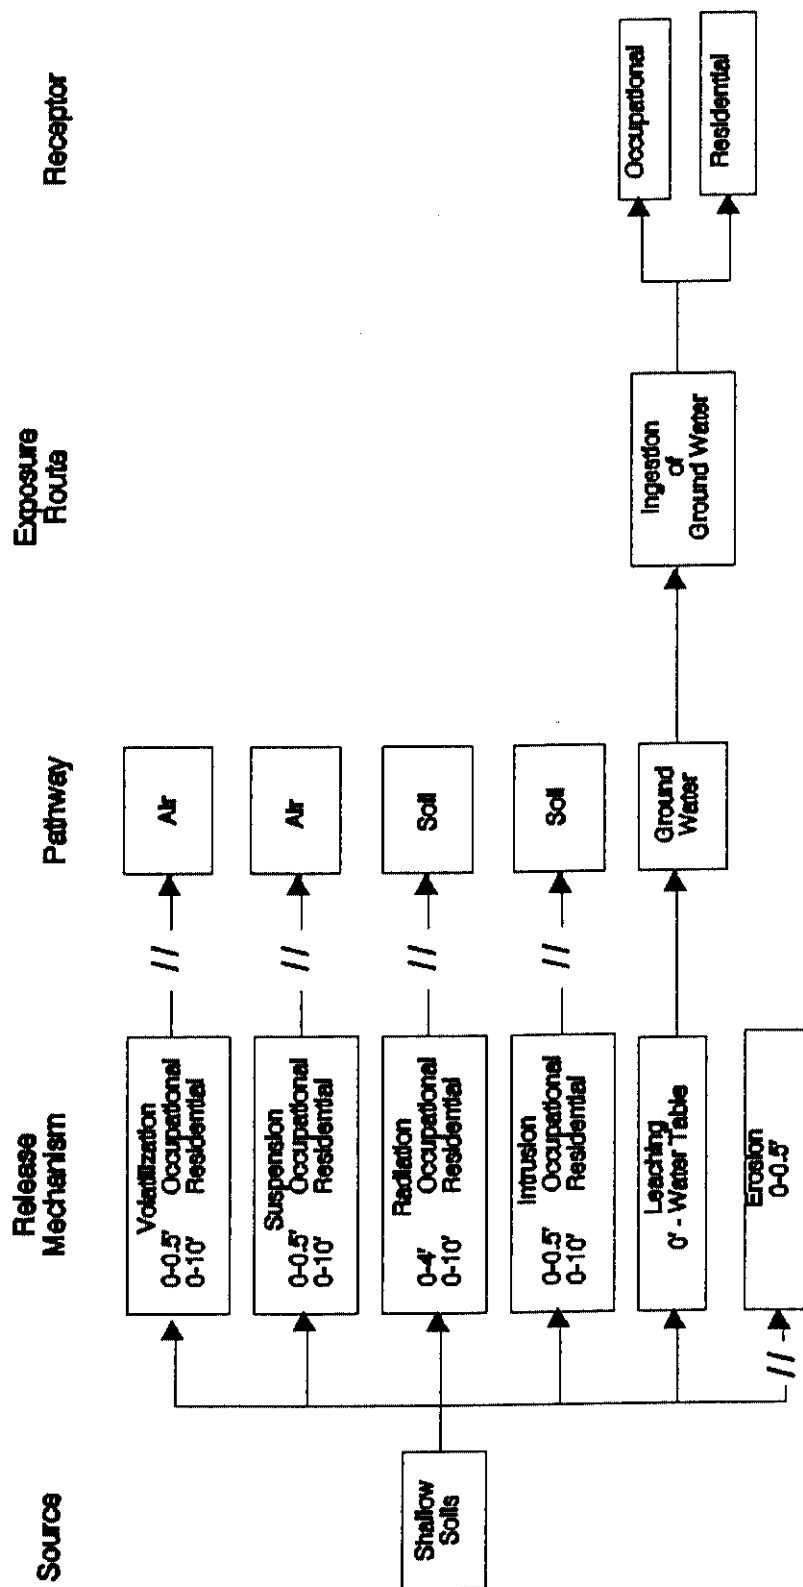
OU 3-07 Track 2  
 CPP-16 Conceptual Site Model

// denotes break in pathway
